**Central and Southeast Texas Recreational Use Attainability Analyses Project
Caney Creek Above Tidal (Segment 1305) Comprehensive RUAA**

Results Report

Contract No. 582-9-90440
EIH Technical Report # 10-003

September 24, 2010

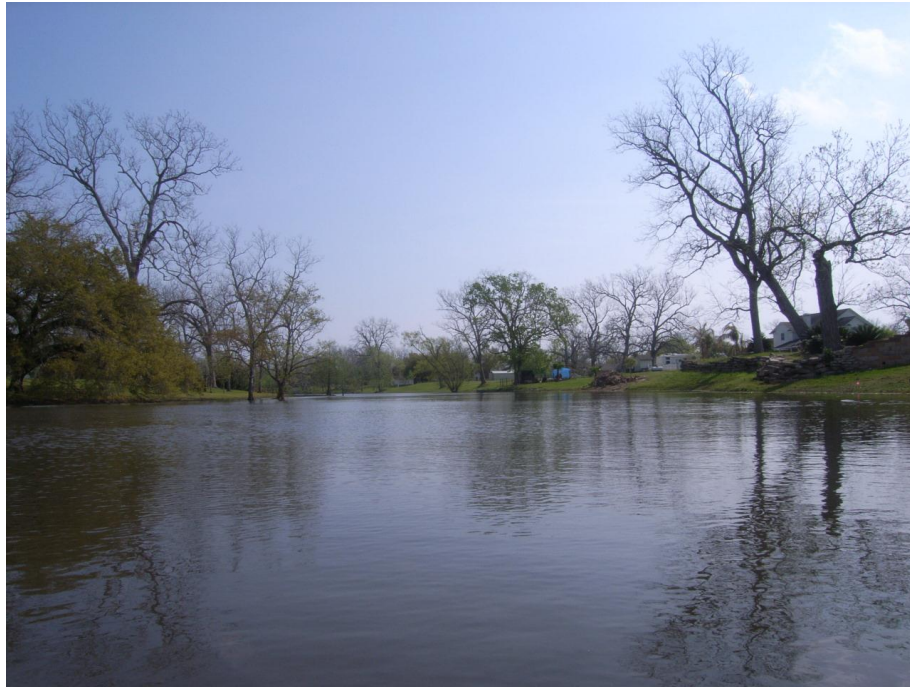
Figure 2. Picture of field survey site 1, showing the general representation of the physical conditions seen on the Caney Creek Above Tidal assessment unit 1305_03

Extensive interviews were collected to help determine what kind of contact recreation occurred along the privately owned portions of the stream. These interviews resulted in additional background information which confirmed that recreation was most likely to occur at sites identified in this study, and also confirmed the many limitations to public access along the stream. Every effort was made for the interviewees to provide recreational use information about the entire length of the segment including areas other than the selected sites in this RUAA. Topographic maps were used to provide the needed geographic information about potential recreational opportunities and potential access points along Caney Creek Above Tidal. The topographic map and aerial imagery review resulted in site selection for the reconnaissance site visits. The reconnaissance site visits confirmed the limited public access along the creek. Caney Creek Above Tidal physical characteristics can be generalized into two categories: AU_1305_03 pool complexes with little to no flow (Figure 2) and AU_1305_01 and AU_1305_02 with more channelized creek (Figure 3). Figure 2 was taken at field survey site 1, and is a good representative of the general site conditions documented in assessment unit 1305_03. Figure 3 was taken at field survey site 16, and is a good representative of the general site conditions documented in assessment units 1305_01 and 1305_02.

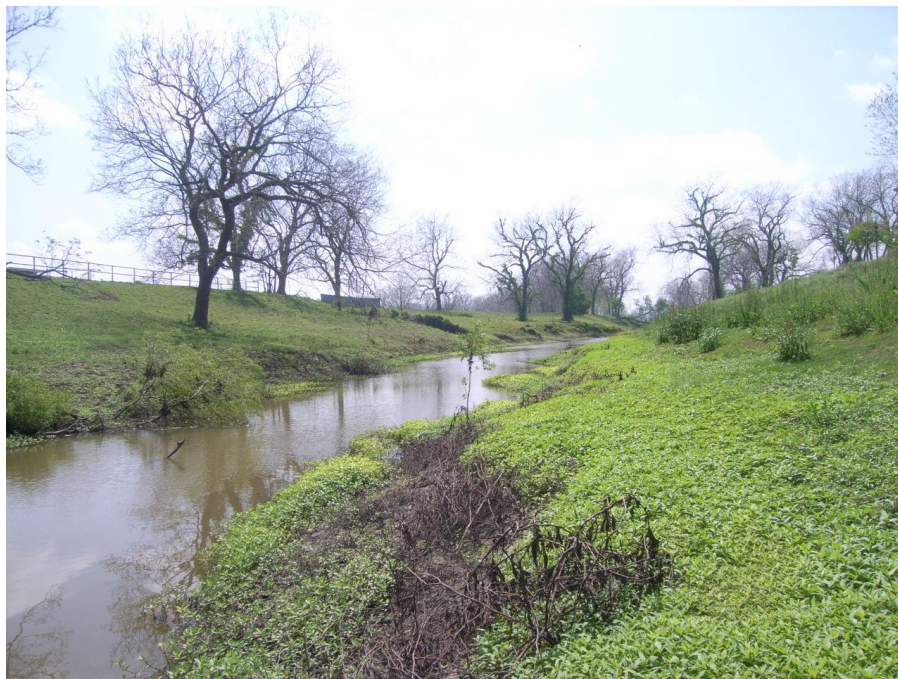
Figure 3. Picture of field survey site 16, showing the general representation of the physical conditions seen on the Caney Creek Above Tidal assessment units 1305_01 and 1305_02
