**Central and Southeast Texas Recreational Use Attainability Analyses Project
Brushy Creek (Segment 1244) Comprehensive RUAA**

Results Report

Contract No. 582-9-90440
EIH Technical Report # 10-006

Prepared by:
George Guillen & Jenny Wrast
University of Houston-Clear Lake

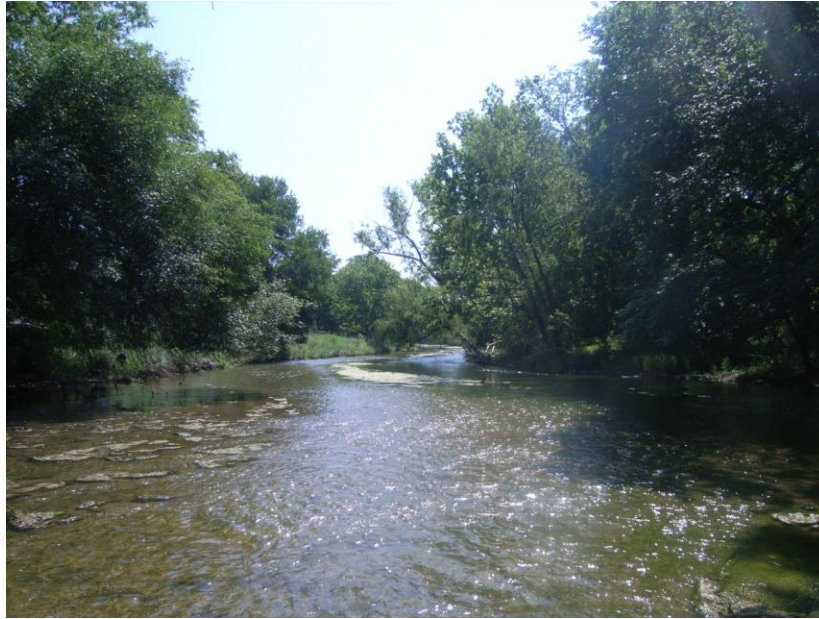
Figure 7 Picture of field survey site 1, showing the general representation of the physical conditions seen on the Brushy Creek assessment units 1244_03 and 1244_04

Extensive interviews were collected to help determine what kind of contact recreation occurred along the privately owned portions of the stream. These interviews resulted in additional background information which confirmed that recreation was most likely to occur at sites identified in this study, and also confirmed the many limitations to public access along the stream. Every effort was made for the interviewees to provide recreational use information about the entire length of the segment including areas other than the selected sites in this RUAA. Topographic maps were used to provide the needed geographic information about potential recreational opportunities and potential access points along Brushy Creek. The topographic map and aerial imagery review resulted in site selection for the reconnaissance site visits. The reconnaissance site visits confirmed the limited public access along the creek. Limited public access due to fences, gates, and no trespassing signage are common on assessment units 1244_01 and 1244_02 of Brushy Creek and resulted in less than three (3) sites for every five (5) miles of stream. Brushy Creek's physical characteristics can be generalized into two categories: assessment units 1244_03 and 1244_04 shallow, wide bedrock dominated creek (Figure 7) and assessment units 1244_01 and 1244_02 with more channelized and deeper creek (Figure 8).

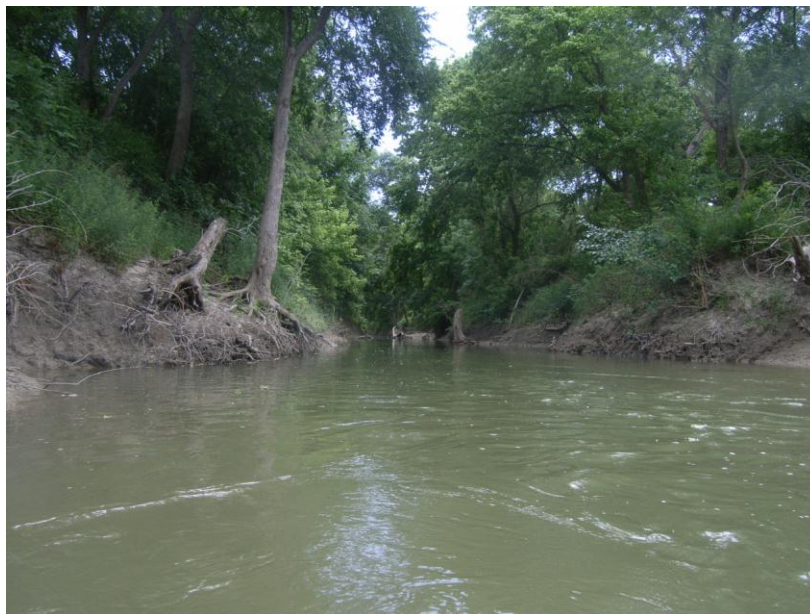
Figure 8 Picture of field survey site 20, showing the general representation of the physical conditions seen on the Brushy Creek assessment units 1305_01 and 1305_02
