# Lake Madeline Bacteria Study Final Report

Dr. George Guillen and Susan Moore  
University of Houston Clear Lake – Environmental Institute of Houston

## Lake Madeline, Galveston

## EIH Technical Report 2-06

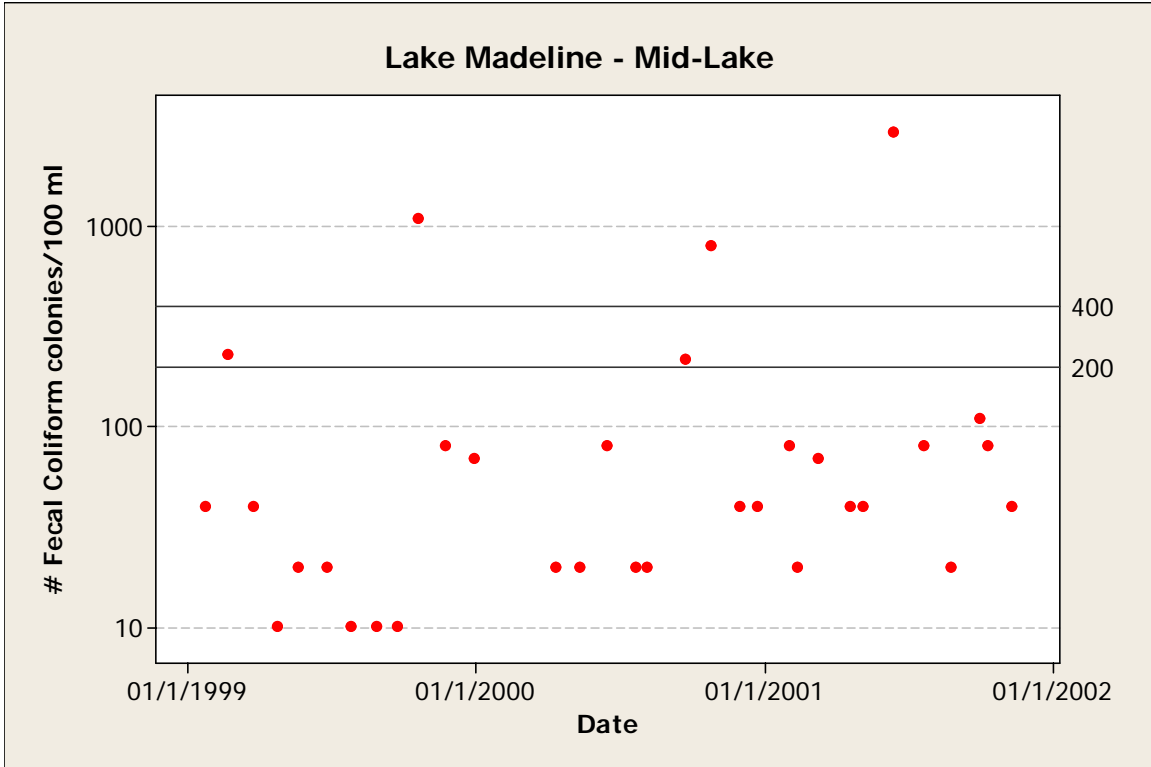
Figure 3. Historical trends in fecal coliform levels in Lake Madeline. The water quality standard is a geometric mean of 200 colonies per 100 ml and a single sample maximum of 400 colonies per 100 ml. Y-axis is log scale.

Historical data suggests that Lake Madeline has been experiencing periodic elevated levels of fecal coliforms and enterococci bacteria since at least 1999 and 2002 respectively (Figures 2 and 3). Since most sampling is conducted during dry weather events it is likely that these values represent a negatively biased estimate of the true concentration of bacteria. Bacteria levels measured during our study were generally comparable to historical values. The slightly elevated levels during recent years suggest that incorporation of more wet weather events may have biased the values higher. This is supported by the observed relationships between salinity, rainfall and enterococci levels (Figure 4 and 5). However, there does not appear to be a strong relationship between fecal coliform levels and salinity (Figure 6). Historical precipitation data was not available for the entire time series of fecal coliform measurements. Water temperature may also have an influence on bacteria levels. Bacteria levels were slightly elevated at higher temperatures (Figures 7 and 8). This is consistent with the general observation that these are thermophilic bacteria and experience optimum growth and survival at warmer temperatures.

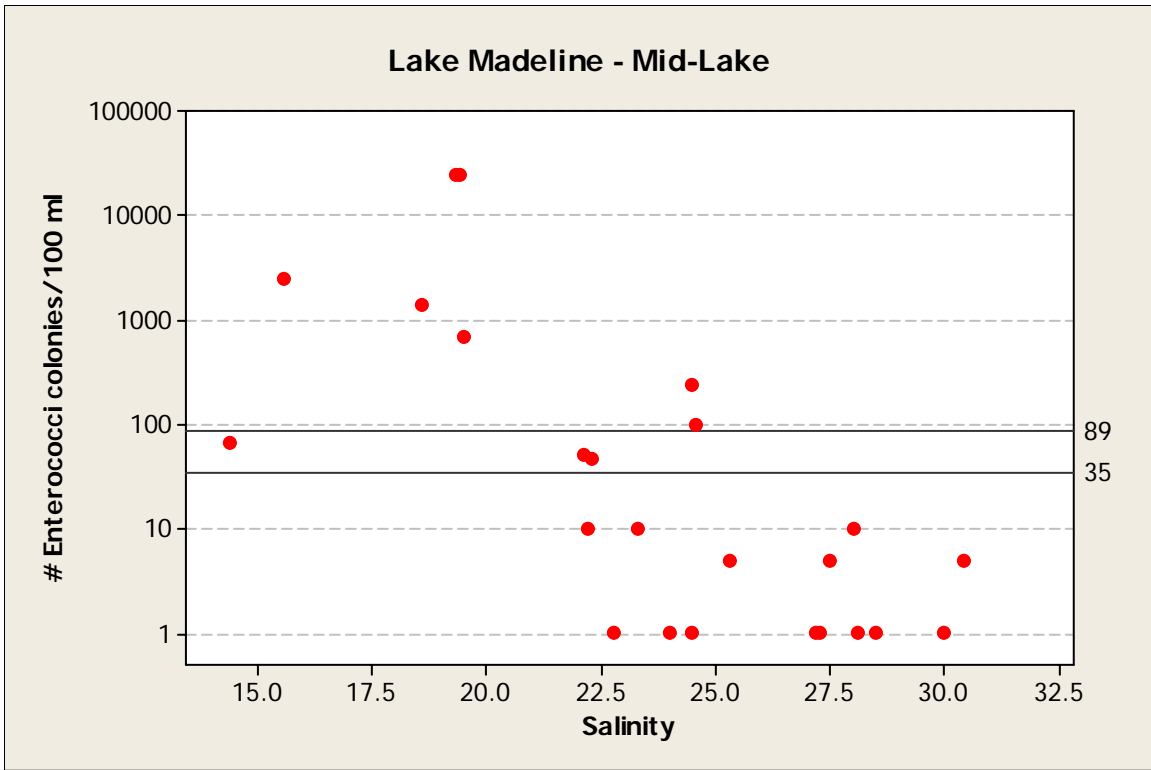
Figure 4. Relationship between enterococci levels and salinity in Lake Madeline between 2002 and 2006. The water quality standard is a geometric mean of 35 colonies per 100 ml and a single sample maximum of 89 colonies per 100 ml. Y-axis is log scale.

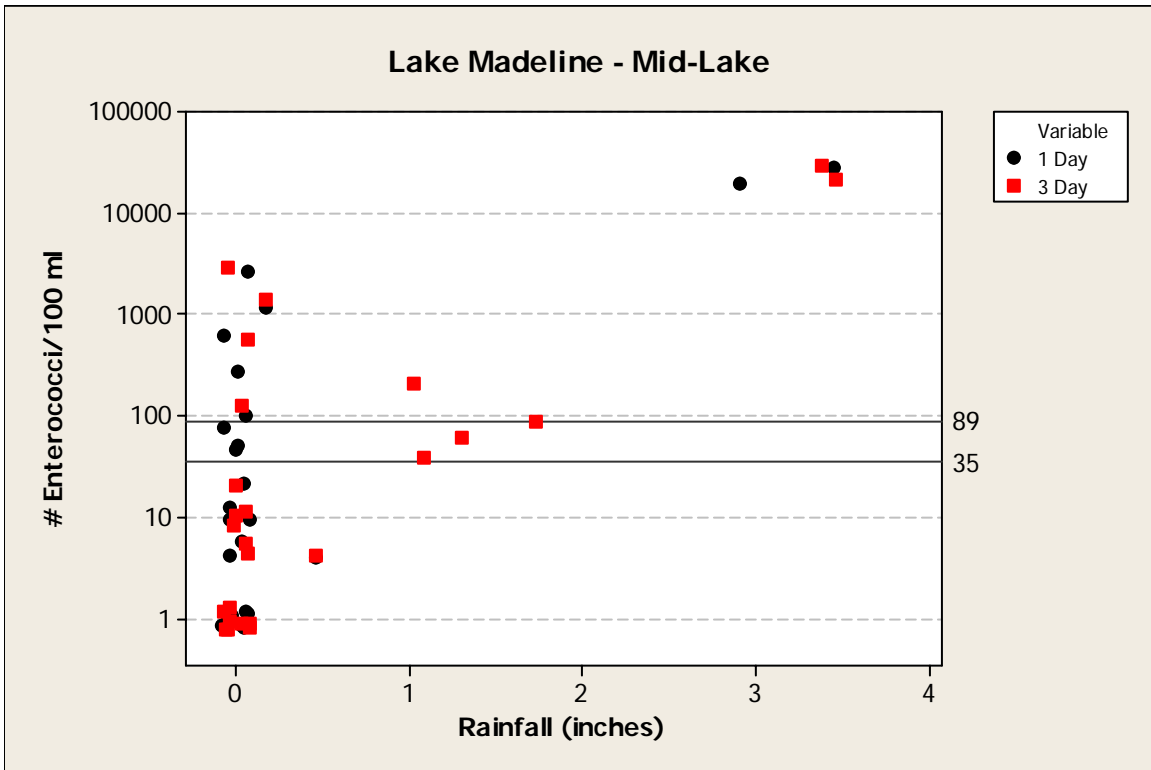
Figure 5. Relationship between enterococci levels and 1 and 3 day rainfall amounts in Lake Madeline between 2002 and 2006. The water quality standard is a geometric mean of 35 colonies per 100 ml and a single sample maximum of 89 colonies per 100 ml. Y-axis is log scale.

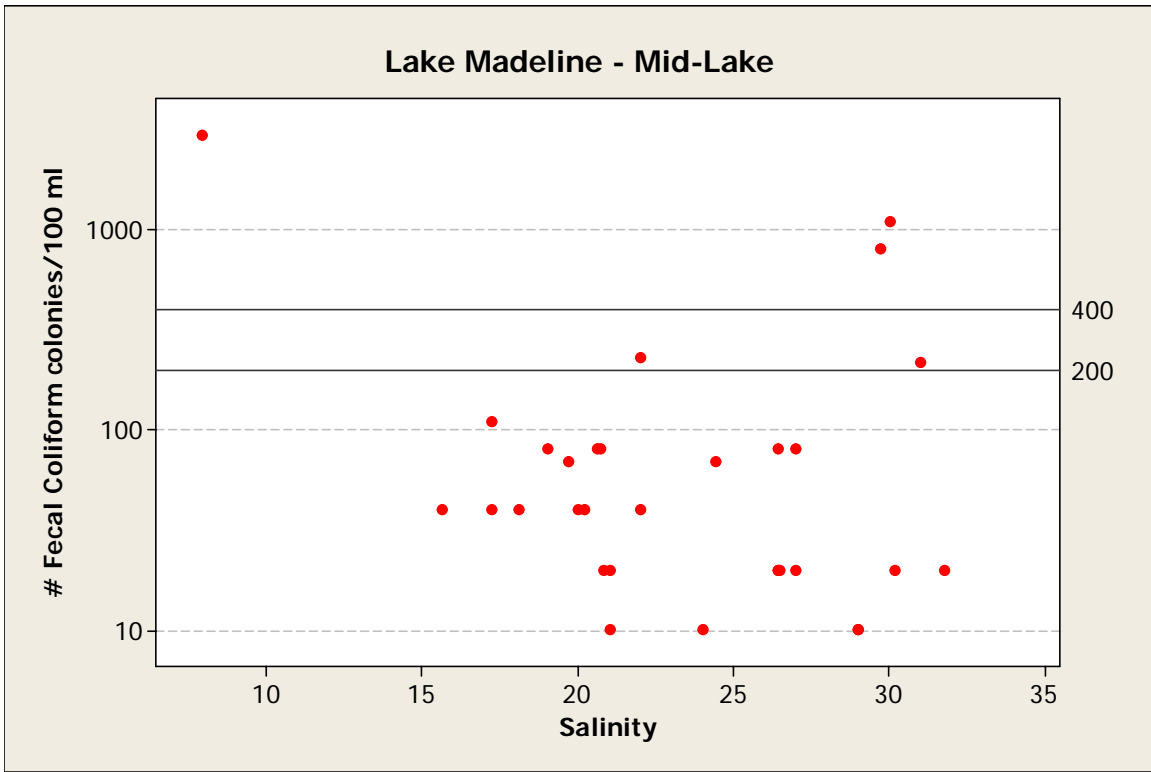
Figure 6. Relationship between fecal coliform levels and salinity in Lake Madeline between 1999 and 2006. The water quality standard is a geometric mean of 200 colonies per 100 ml and a single sample maximum of 400 colonies per 100 ml. Y-axis is log scale.

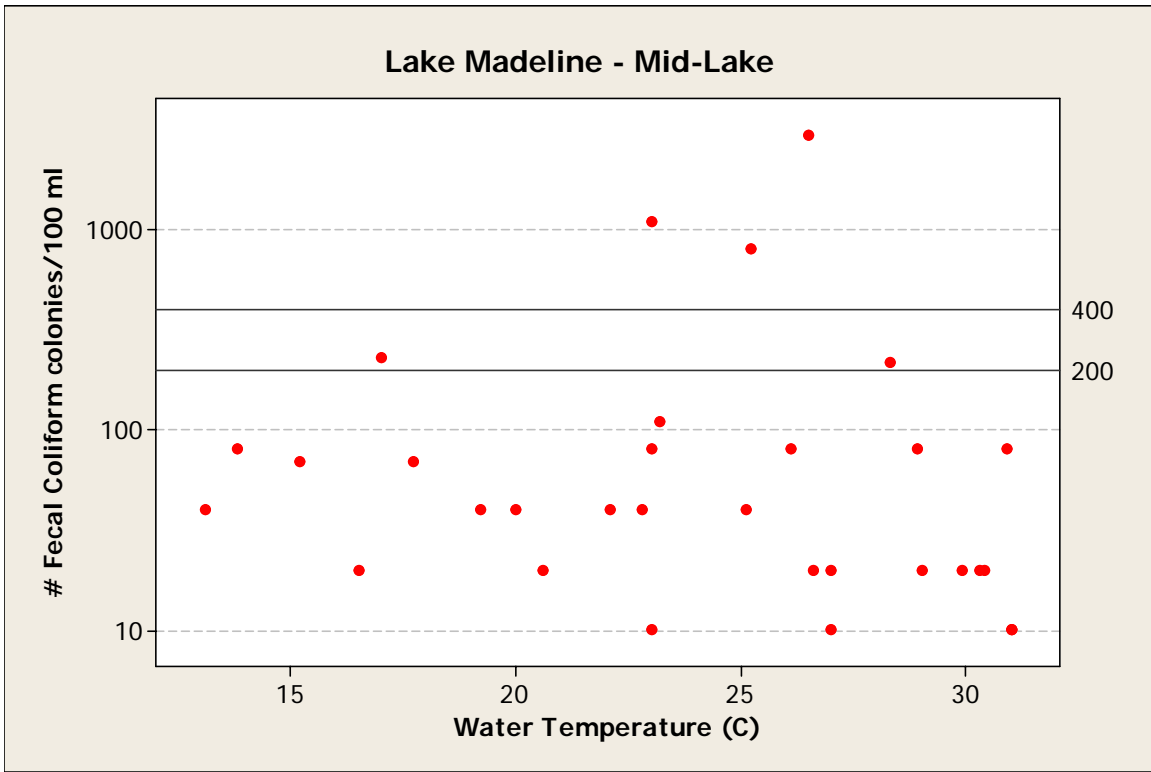
Figure 8. Relationship between fecal coliform levels and water temperature in Lake Madeline between 2002 and 2006. The water quality standard is a geometric mean of 200 colonies per 100 ml and a single sample maximum of 400 colonies per 100 ml. Y-axis is log scale.

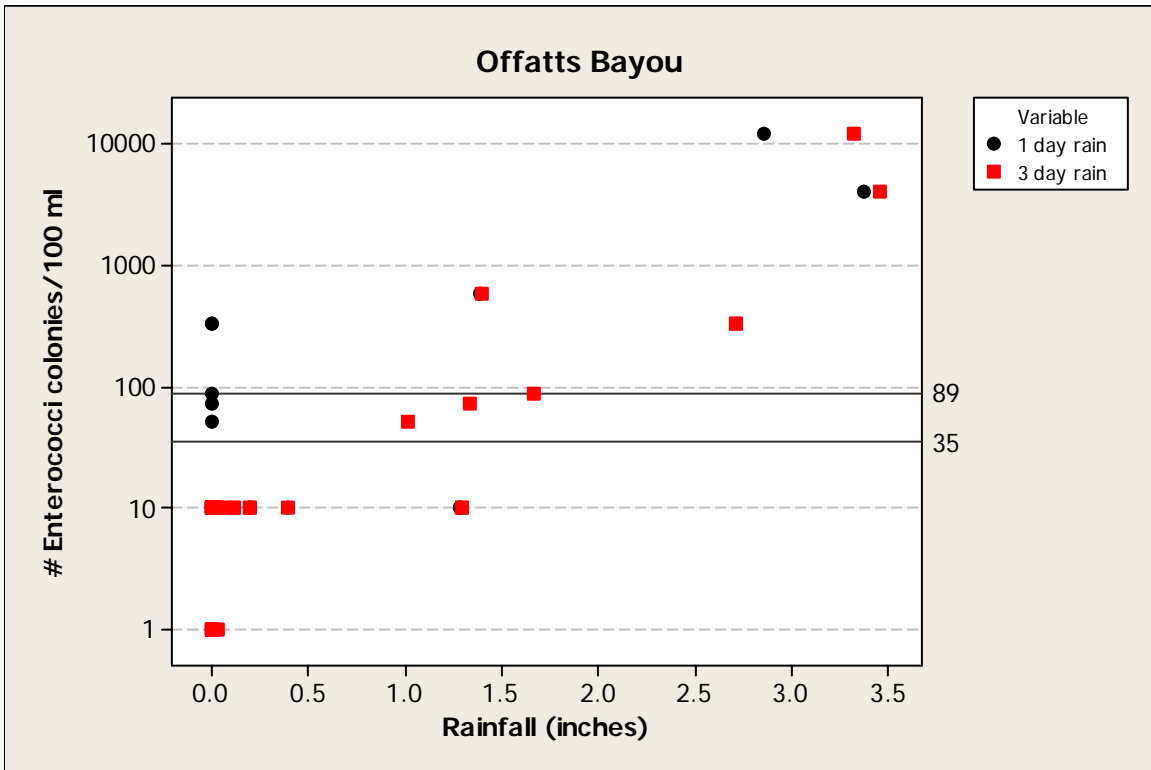
Figure 10. Relationship between enterococci levels and 1 and 3 day rainfall amounts rainfall in Offatts Bayou between 2001 and 2006. The water quality standard is a geometric mean of 35 colonies per 100 ml and a single sample maximum of 89 colonies per 100 ml. Y-axis is log scale.

This is supported by the observed relationships between rainfall and enterococci levels in Offatts Bayou (Figure 10). We did not have a complete extensive time series for fecal coliform bacteria and salinity data, so we were not able to conduct those analyses.

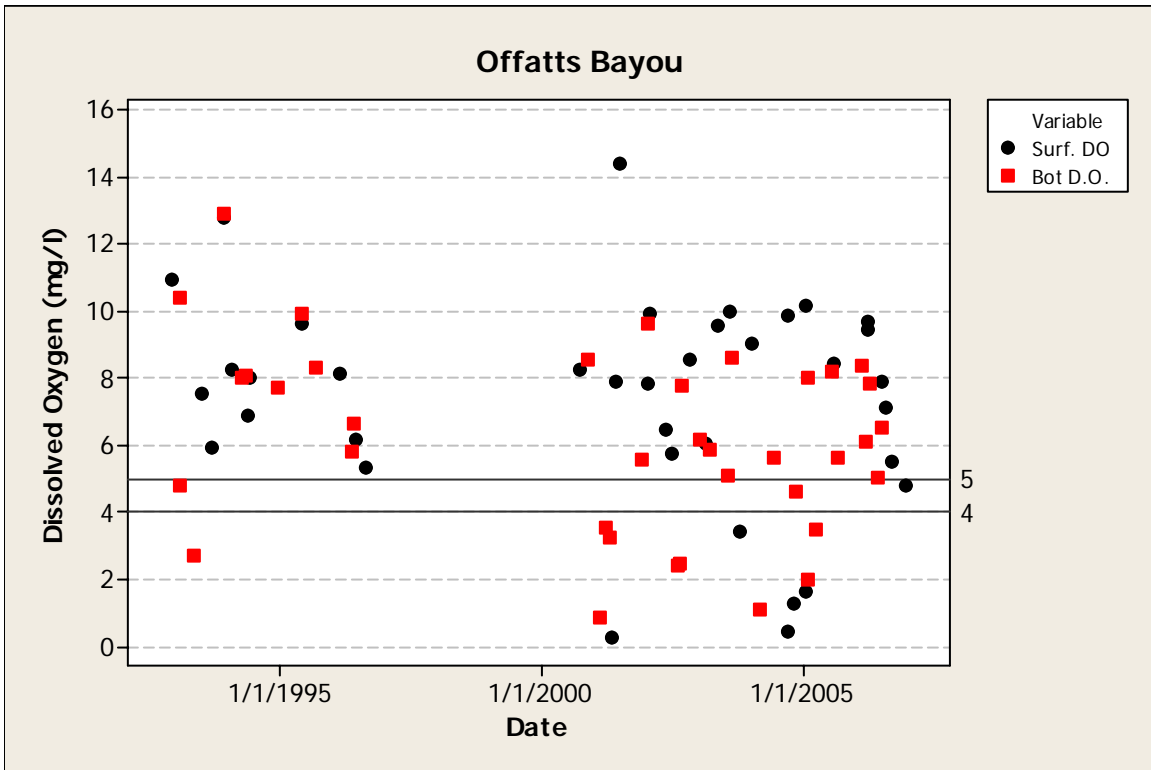
Figure 12. Dissolved oxygen levels measured at the surface (1 ft) and 1 ft above the bottom at Offatts Bayou. The water quality standard is a 24 hour minimum average of 5 mg/l and an 8 hour minimum of 4 mg/l.

Historical data suggests that Lake Madeline and Offatts Bayou have been experiencing periodic hypoxia since 2005 and 2001 respectively (Figures 11 and 12). Dissolved oxygen levels were generally lowest near the bottom. The incidence of hypoxia was more frequent at Lake Madeline, which also exhibited a wider variation between surface and bottom readings. This suggests that Lake Madeline is more stratified and less mixed than Offatts Bayou. As previously mentioned fish kills have been recorded in Offatts Bayou by Texas Parks and Wildlife Department (Winston Denton – TPWD pers. comm.). Fish kills in Offatts Bayou are rare and have not reported in recent years.

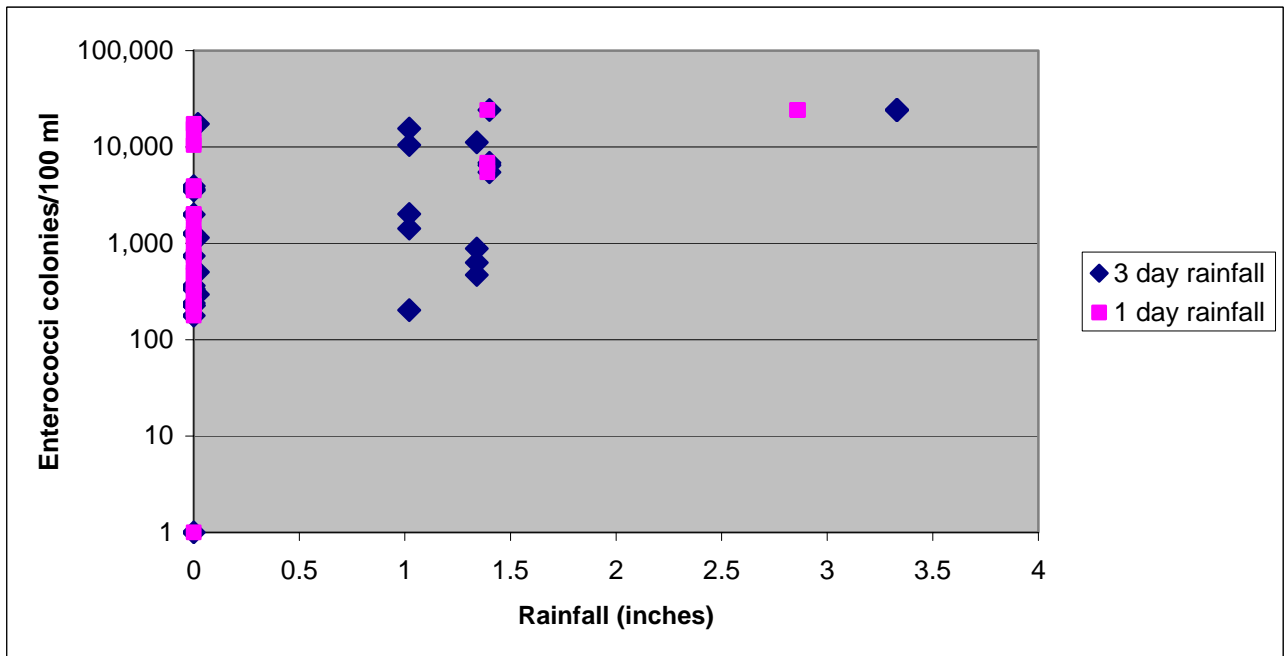
Figure 14. Comparison of enterococci levels and 1 and 3 day rainfall amounts at selected storm sewers (COG 1-4) monitored during dry and wet periods. The data point for the 2.86 and 3.33 inches of rainfall amount represents 5 sites, i.e. 5 observations. Y-axis is log scale.

These findings suggest that there appears to be a positive relationship between enterococci levels at storm sewer sites monitored during dry and wet weather events (COG 1-4), and precipitation (Table 3; Figures 1, 13 and 14). This is especially evident when evaluating the influence of 3 day accumulated rainfall as measured at the Scholes Field NWS Station. Similar trends were observed in the open waters of Lake Madeline (Table 3; Figures 1, 13 and 15). These observed relationships further support our hypothesis that malfunctioning wastewater collection systems may be a significant source of indicator bacteria within the watershed.

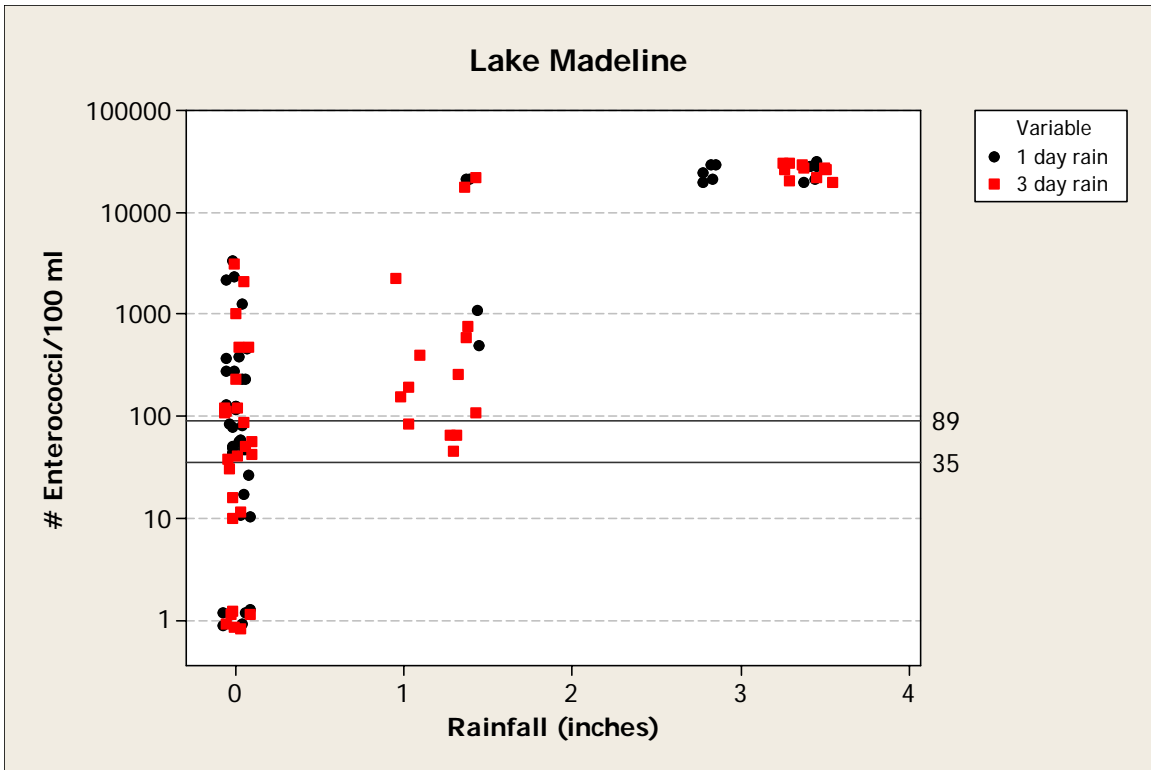
Figure 15. Comparison of enterococci levels and 1 and 3 day rainfall amounts at open water sites within Lake Madeline monitored during dry and wet periods. The data points for the 3.3 and 3.46 inch rainfall amounts represent all 5 sites, i.e. 5 observations. Y-axis is log scale.

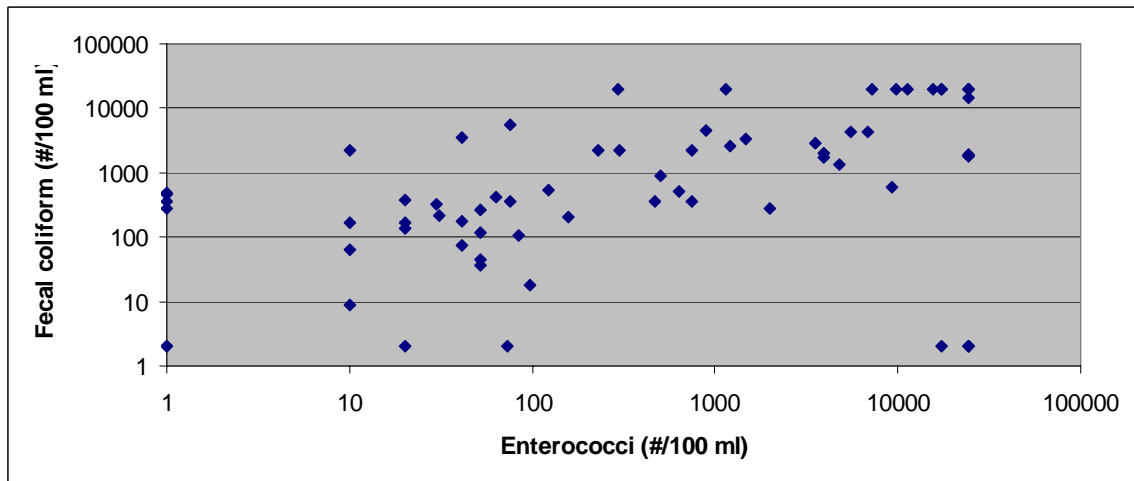
Figure 16. Comparison of enterococci and fecal coliform levels monitored on selected dates of the study period. Y and X-axis is log scale.

We also monitored fecal coliform and fecal streptococci indicator bacteria levels at selected sites on August 9 and 25 and September 9 and 24. Although not strongly correlated, those data show similar trends with enterococci levels (Figure 16). In order to estimate the possible source of the observed bacteriological indicator levels we also conducted fecal streptococcus tests and constructed FC/FS ratios for a subsample of dates and sites (Table 4). Our data and analyses suggest that most of the bacteria are probably of human or mixed origin. Approximately 54%, 29% and 16% of the samples appeared to be composed of bacteria from human, animal and mixed origin respectively. Some notable exceptions included Offatts Bayou, Sydnor Bayou and some of the storm sewers located in the southeast end of Lake Madeline which drain the Wal-Mart area. Samples from these sites indicate bacteria of animal origin. Again the reader is reminded that the FC/FC ratio method is considered a very rough screening method and should not be used to definitively determine the origin of these bacteria.
